# Manhole Inspection Summary

Manhole # S15U\_\_001MH

Insp Date: **11/26/08 1:57 PM**

**Location** Address: **2900- Whistler Ave.**

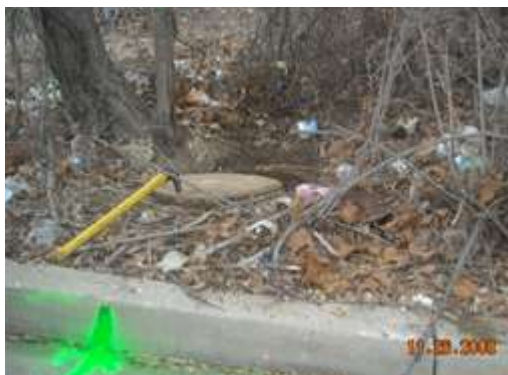
Location View

Pavement marked also tree flagged

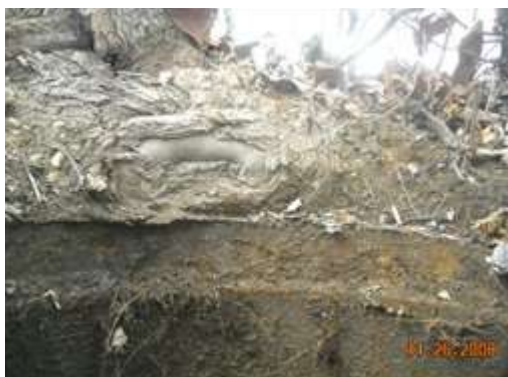
Misc

Comments **Metal detector was used to locate manhole in grass, also had to dig down seven inches to access cover. When manhole was reached cover was stuck. Request that manhole be brought up to grade at a later date.**

**Cover** Shape: **Circular** Diameter: **24** (in.) Length: **0** (in.) Dist A/B Grade: **-7** (in.)

Frame is seven inches below grade

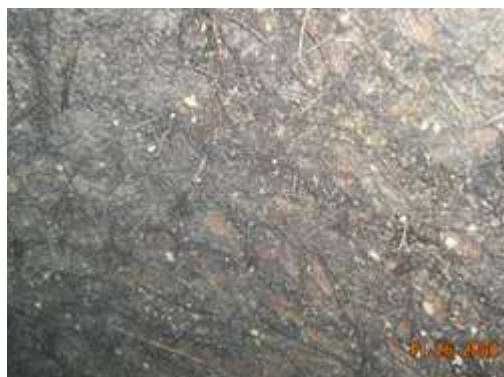
Defect 3

Condition: ☐ Sound ☐ Cracked ☒ **Root Intrusion** ☐ Loose Brick ☐ Deteriorated

Infiltration: ☐ None ☐ Joint ☐ Cracks ☐ Mortar ☒ **Roots** ☐ Wall

Root intrusion at corbel wall with signs of infiltration

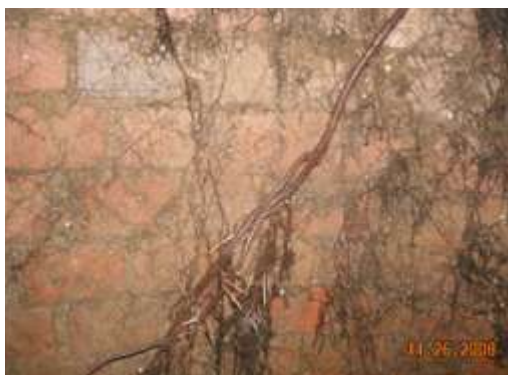
Defect 4

Condition: ☐ Sound ☐ Cracked ☒ **Root Intrusion** ☐ Loose Brick ☐ Deteriorated

Infiltration: ☐ None ☐ Joint ☐ Cracks ☐ Mortar ☒ **Roots** ☐ Wall

Root intrusion on barrel wall with signs of infiltration

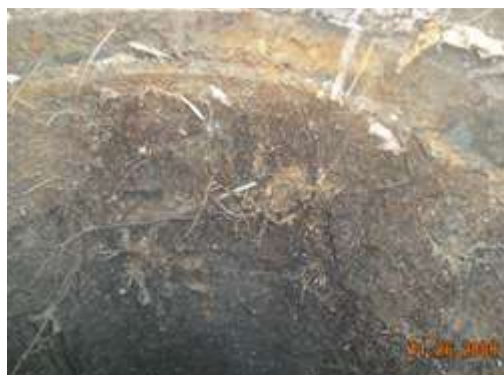
Defect

Root Intrusion at the frame

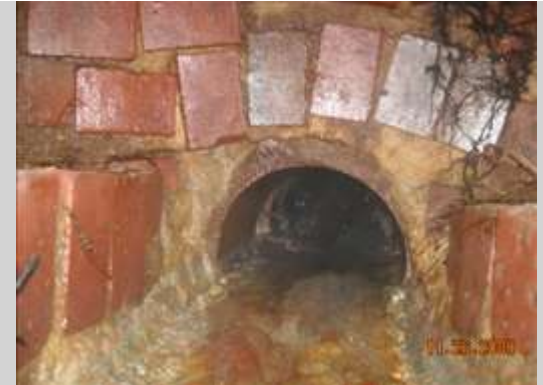
12 O'Clock Outflow

8 in. Circular Gravity Sewer  
Pipe Out @ 12 O'Clock

Pipe Height: **7.2** (in.) Rod and Bar (Angled)  
Pipe Material: **Clay** ☐ Pipe Lined  
Invert Depth: **8.60** (ft.) Flow Characteristics: **Slow**  
Deposits: ☒ None ☐ Mud ☐ Sludge ☐ Debris ☐ Grease  
Silt Depth: **0** (in.) Deposits Extent:  
Infiltration: **None** Pipe Seal Cond: **Sound**

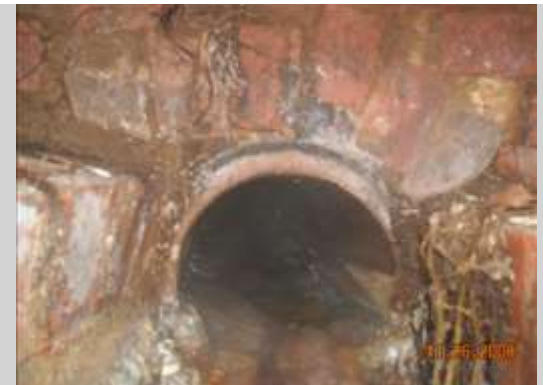
5 O'Clock Inflow

8 in. Circular Gravity Sewer  
Pipe In @ 5 O'Clock

Pipe Height: **8.4** (in.) Rod and Bar (Angled)  
Pipe Material: **Clay** ☐ Pipe Lined  
Invert Depth: **8.33** (ft.) Flow Characteristics: **Slow**  
Deposits: ☒ None ☐ Mud ☐ Sludge ☐ Debris ☐ Grease  
Silt Depth: **0** (in.) Deposits Extent:  
Infiltration: **None** Pipe Seal Cond: **Sound**
